CEREC 3D/inLab 3D: Service Pack V3.65

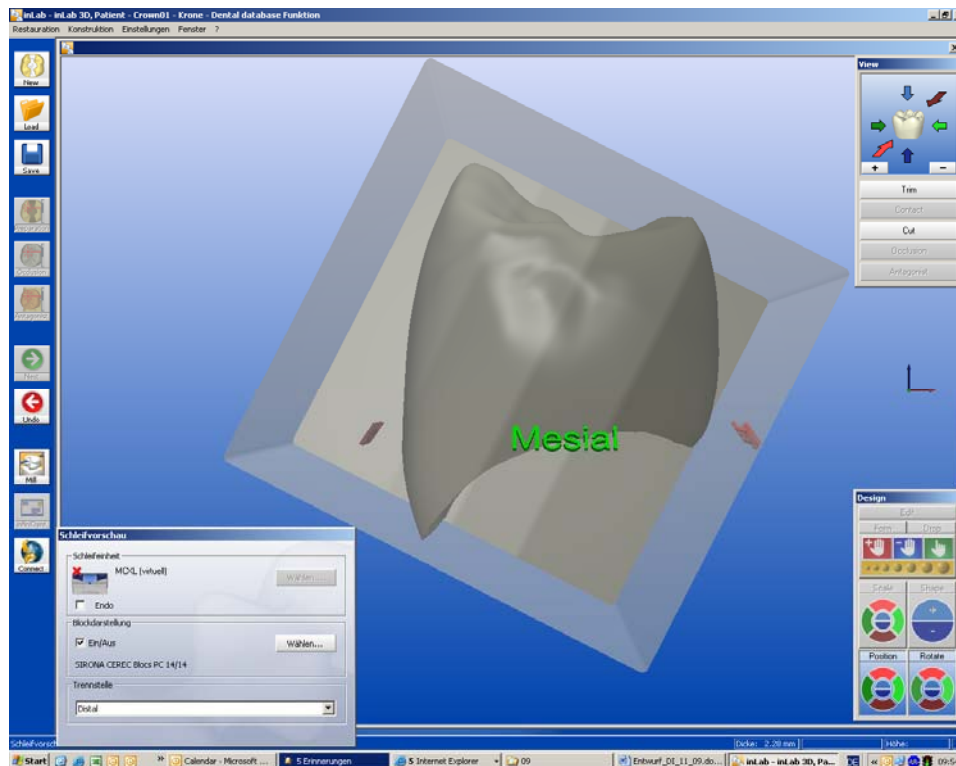
Rotation of restorations in the milling preview for polychromatic blocks

In combination with a CEREC/inLab MC XL milling machine it is now possible to rotate restorations by $\pm 90^\circ$ within a polychromatic block in order to achieve a better aesthetic result. This applies to the following materials:

The restoration can be moved and rotated by pressing the “Position” and “Rotate” buttons. The diagonal positioning of the restoration necessitates a preliminary milling process in order to ensure that the bur has unrestricted access to the lumen. This takes a few minutes. During this preliminary milling process, the edges of the block are removed.
